Remote Sensing and Field Assessment of Tsunami Effects on Coastal Pond Aquaculture in Northern Sumatra

S. P. Kam, S. C. Liew, Z. A. Muchlisin and P. Chen

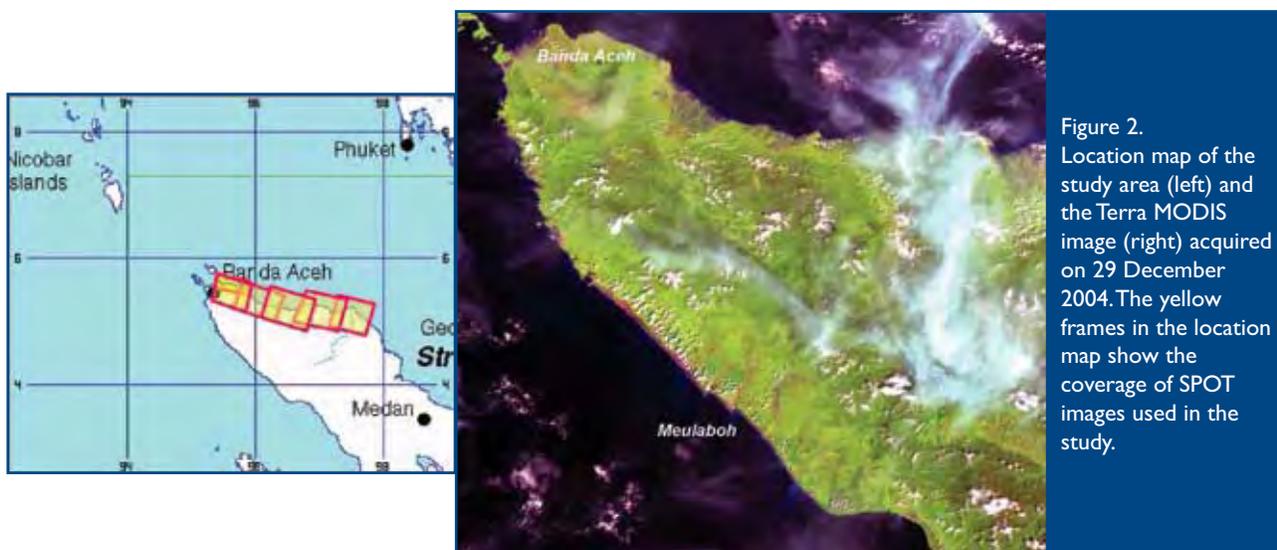
damage was most severe. The few coarse-resolution satellite images available covering the eastern coastal area, such as the wide-coverage Terra MODIS image (Fig. 2), did not permit identification of detailed features for damage assessment.

Figure 2. Location map of the study area (left) and the Terra MODIS image (right) acquired on 29 December 2004. The yellow frames in the location map show the coverage of SPOT images used in the study.

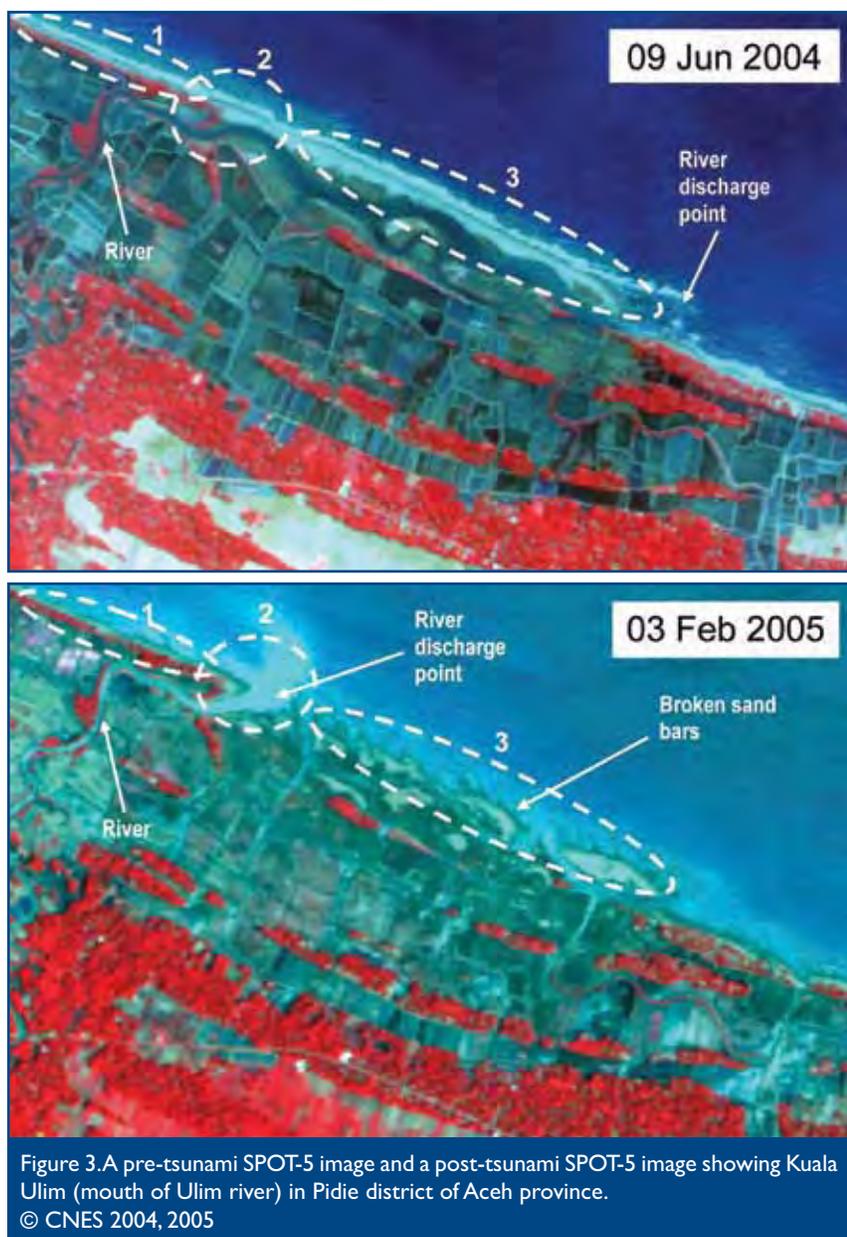
Fig. 3 shows the level of spatial detail discernible from two SPOT-5 sub-scenes depicting the pre- and post-tsunami situation along the stretch of coast bordering Pidie and Bireun districts. Aquaculture ponds with intact dykes can be seen in the pre-tsunami image of 9 June 2004. The western part of the coast in this sub-scene is lined with long sand bars (annotated with 1, 2 and 3). In the post-tsunami (2 February 2005) image of the same area, the pond dykes appear less distinct, indicating damage, and the ponds appear to have fallen into disuse. Damage to other coastal features is also evident. For example, in the northwest corner of the pre-tsunami image, a small river can be seen flowing parallel to the coast, inside of the long sand bar, and discharging into the sea further eastward in the sub-scene. The post-tsunami image shows that the river discharge point has shifted more to the west (location 2) because the eastern bit of sand bar has been broken. This could have exacerbated the damage to the aquaculture ponds that were previously protected by the sand bar. The aquaculture ponds that are further inland and protected by the vegetated sandy ridges (red strips in the image) appear to be unaffected. The stretch of beach in the northwest part of the image (location 1) also appears relatively intact. Such information is also useful for assessing the impact of coastline changes on fisheries and other coastal activities that are important for rebuilding the livelihoods of the affected communities.

Figure 3. A pre-tsunami SPOT-5 image and a post-tsunami SPOT-5 image showing Kuala Ulim (mouth of Ulim river) in Pidie district of Aceh province.
© CNES 2004, 2005

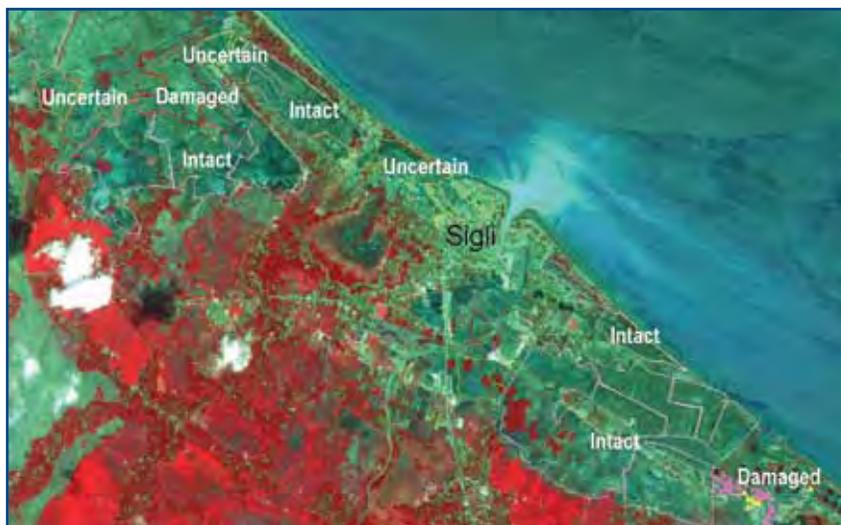
Fig. 4 shows a subset of the pond damage assessment map produced for the stretch of coastal area in the vicinity of Sigli town in Pidie. Delineated polygons of aquaculture

pond clusters, annotated with “intact”, “damaged” and “uncertain” classes, are superimposed on the post-tsunami SPOT-5 image.

Figure 4. Part of a post-tsunami SPOT-5 image near Sigi overlaid with polygons of damage classes. SPOT image © CNES 2005.

Also evident are other features of the coastal zone that would provide useful spatial information including the spatial pattern of human settlements and land use, coastal forests, infrastructure networks, providing sufficient detail to be directly used as a base map

for various reconstruction planning purposes. Large-format prints were made of the image map, comprising the mosaic of post-tsunami SPOT-5 scenes covering the entire 700 km stretch of coast as backdrop, overlaid with the delineated polygons of aquaculture ponds and annotated with names of main towns and river mouths. The prints were brought back to Aceh for carrying out the field assessment and are available for other uses as well.
